Limited Visual Dam Safety Inspection Summary Report

MA-092

Papaaea Reservoir

Limited Visual Dam Safety Inspection Conducted on: 05 April 2006

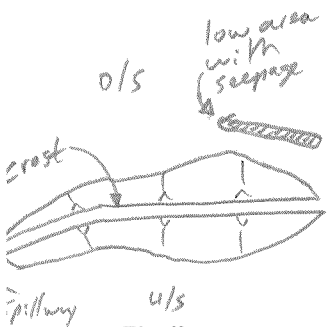
Seepage: Seep Spot Number 1
☐ Green Vegetation ☒ Wet or Muddy Ground ☒ Ponding Water ☐ Not Visible ☐ None Observed
☒ Flowing, Description: About 5 gpm flow rate, clear
Water Clarity: ☒ Clear ☐ Some particles ☐ Muddy ☐ Other: _____
Description: Light seepage on right side of valley floor in low area. Owner should monitor the seepage area.

- ☐ a. The abutments/toe were not inspected.
- ☐ b. The abutments/toe appeared to be in satisfactory condition, no corrective actions are required at this time.
- ☒ c. The abutments/toe appeared to be in fair to poor condition and requires corrective action.
- ☐ d. The abutments/toe appeared to be in unsatisfactory condition and not expected to fulfill its intended function. Urgent corrective action is required.

- ☒ j. Seepage/Ponding water was observed. Monitor and conduct further investigation to locate the source of water and extent of any possible hazardous or developing condition.
